NUYAKA MISSION

SUMMARY OF STUDY TEAM FINDINGS

prepared by:
Study Team
Oklahoma Historical Society
Wiley Post Historical Building
Oklahoma City, Oklahoma

March 1988

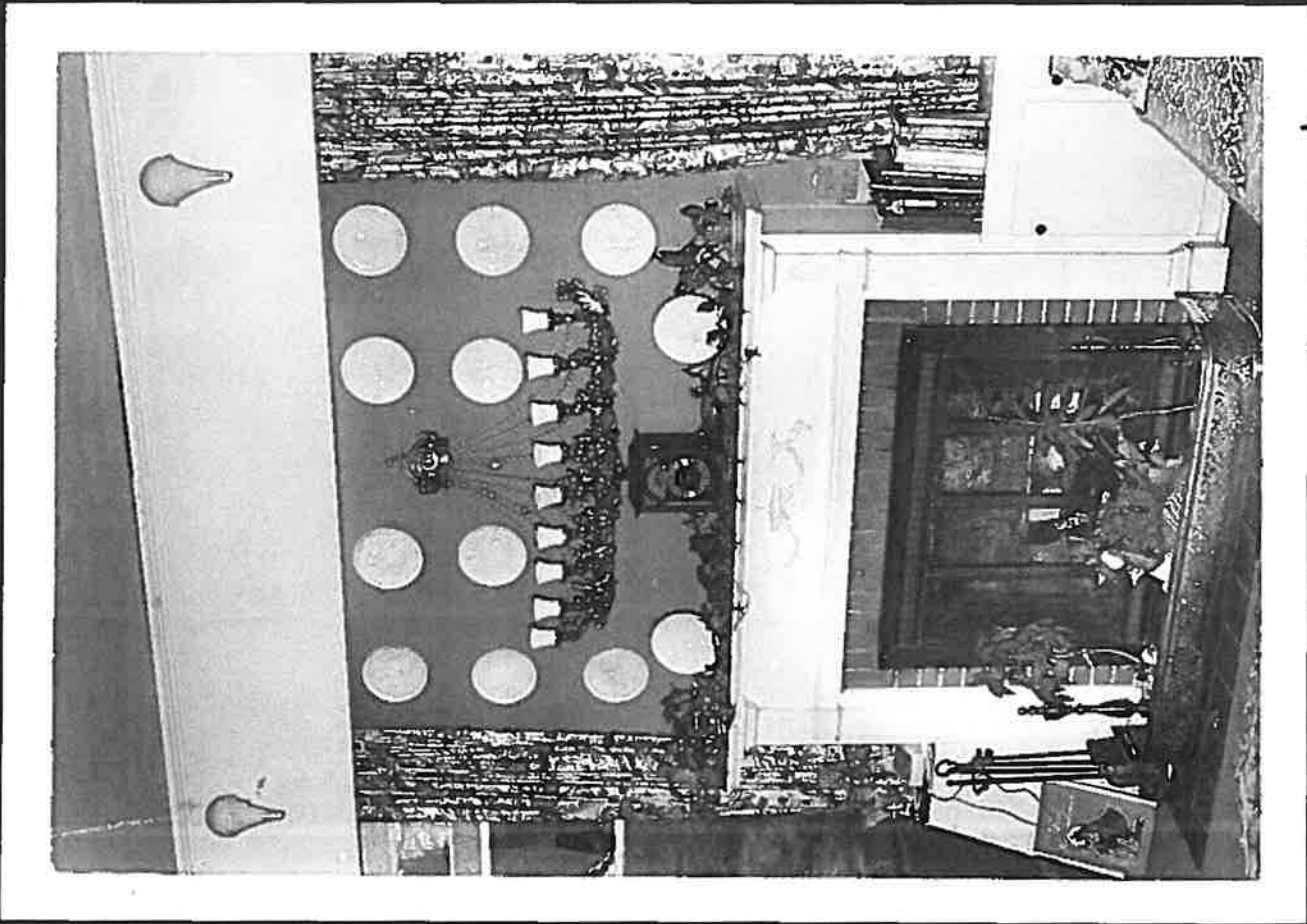
Interior areas of the house are a mixture of historic fabric and later work. Wood shelves and drapery valances are combined and conceal a great deal of the historic wall surfaces. All walls are covered with framed photos and art work of all kinds. The area not concealed by hung art and photos is covered with furniture. Interior doors reveal mortise and tenon construction hung with original butts and latches. Much plaster and lath of the two story building has been removed and replaced with sheet rock (walls and ceilings). Originally constructed with no closets, the owner has built-in these conveniences in each bedroom. The wood trim, originally stained, has been painted white throughout. The stair from the entry hall to the second floor has been divided at midpoint with a door to control the climate indoors, the lower floor being heated and cooled, the second floor not. The kitchen is contained in the addition with access to an enclosed back porch and basement below.

NUYAKA MISSION - OKMULGEE COUNTY
FIRST FLOOR LIVING ROOM FIREPLACE
MANTEL, DRAPERY VALANCE, LOW
STORAGE & WALL-TO-WALL CARPET.

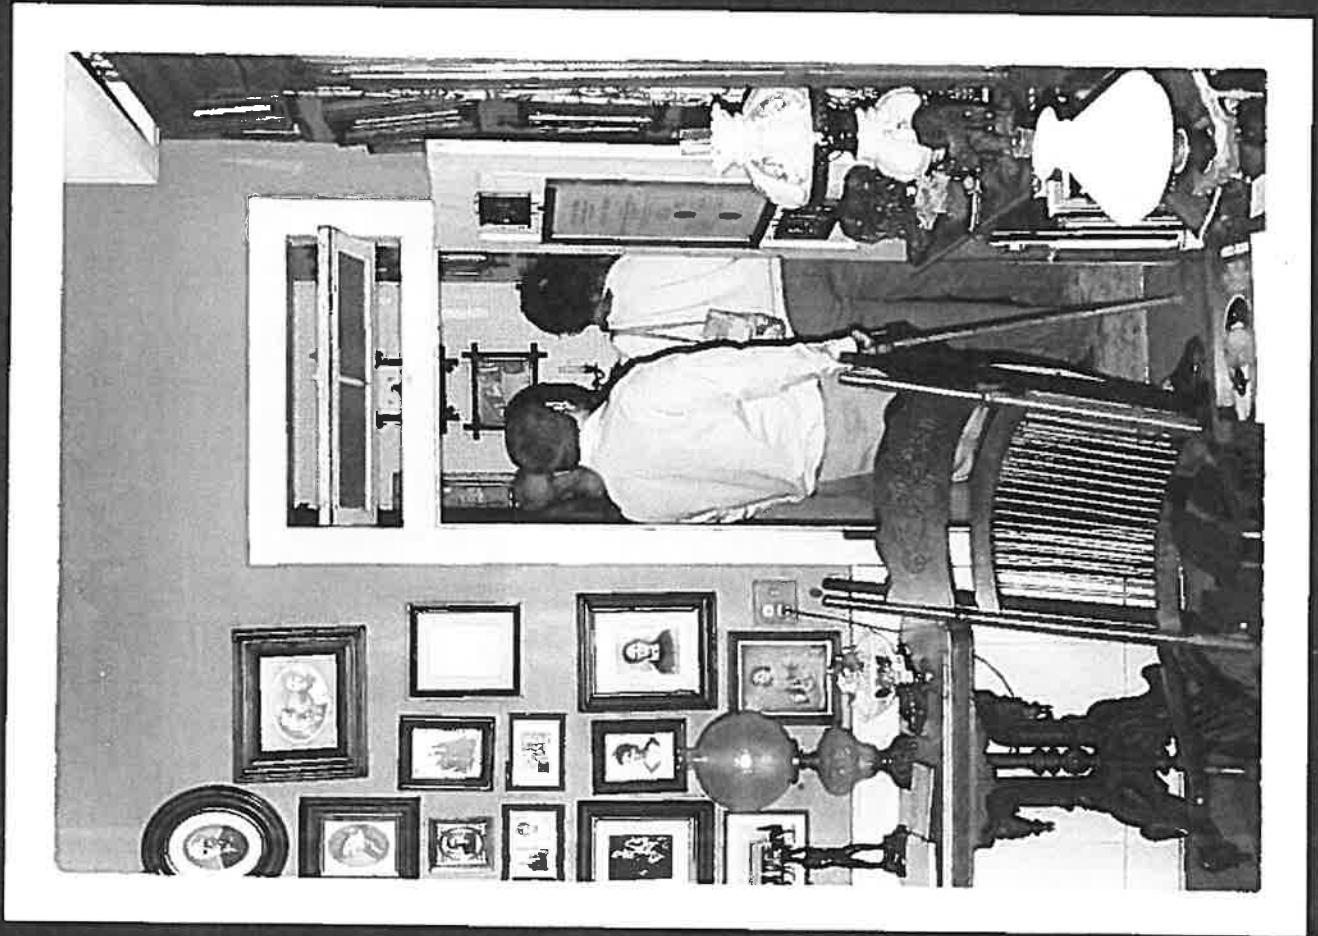
NUYAKA MISSION - OKMUGEE COUNTY
LOOKING FROM FIRST FLOOR LIVING
ROOM TO ENTRY HALL WITH EXHIBITS.

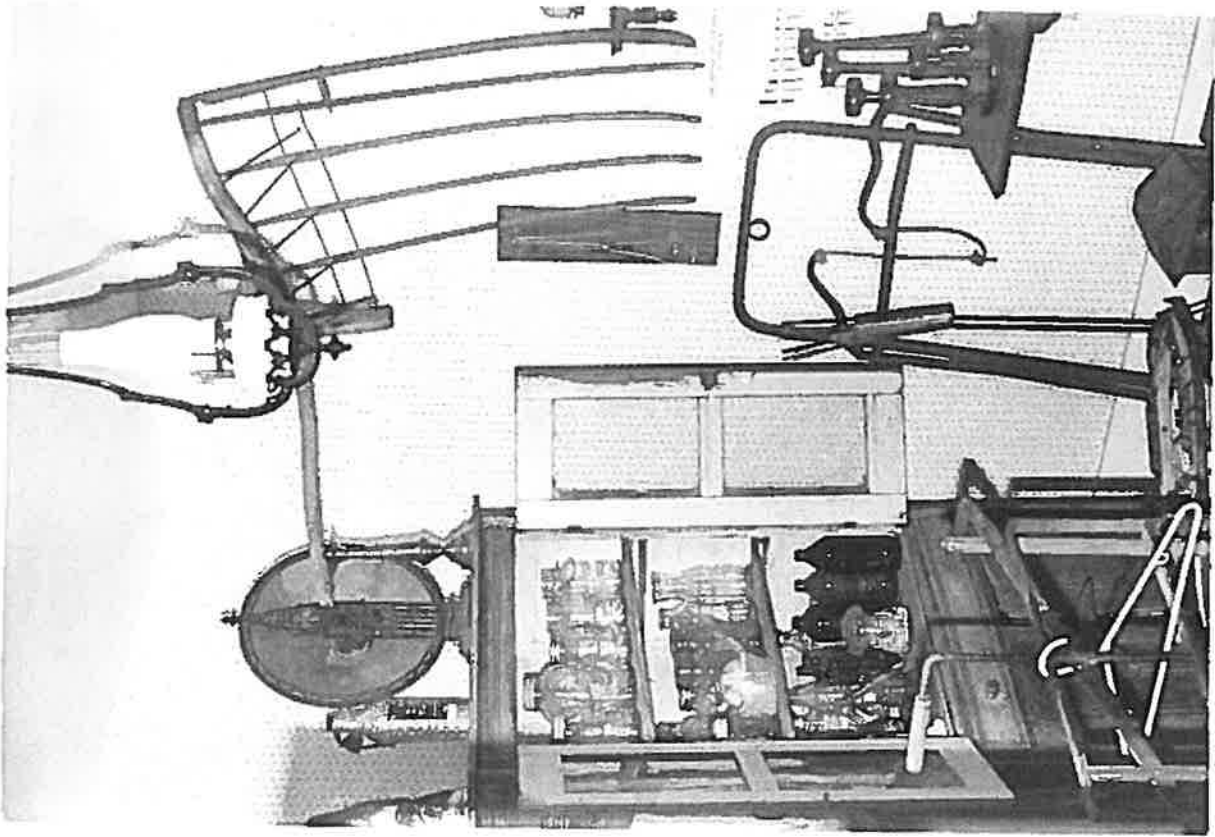
NUYAKA MISSION - OKMULGEE COUNTY
SECOND FLOOR EXHIBIT ROOM OF TOOLS
AND IMPLEMENTS FOUND ON GROUNDS
OR GIFTS.

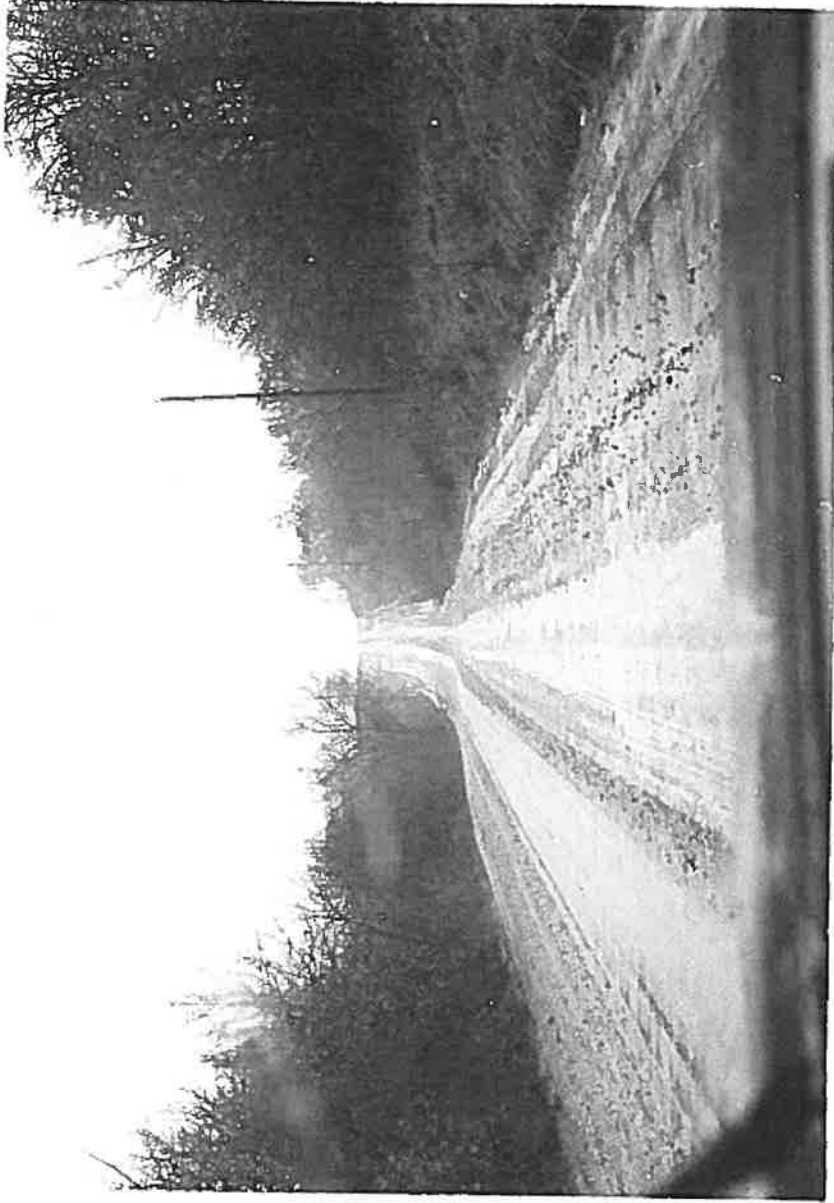
Nuyaka Mission is approximately eleven miles from Okmulgee. It is a thirty-five minute drive from Interstate Highway 40. From the state highway, the mission is a five minute drive over dirt and gravel roads. A single-lane driveway lined with trees leads from the public roadway to the mission building and related sites.

NUYAKA MISSION - OKMULGEE COUNTY
THE ROAD BETWEEN THE MISSION AND
THE HISTORIC MARKER ON THE ALL
WEATHER ROAD.

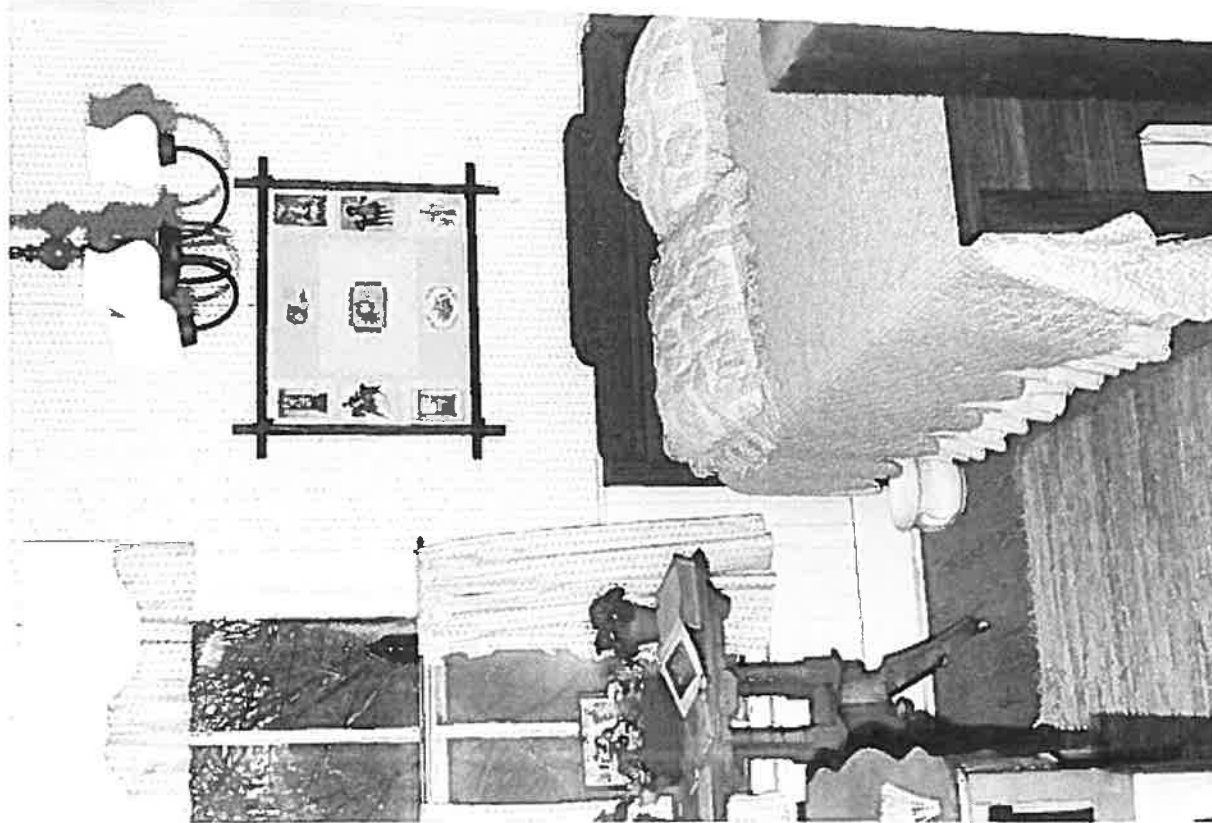
NUYAKA MISSION - OKMULGEE COUNTY
FIRST FLOOR BEDROOM IN SUPER'T'D'T
HOUSE.

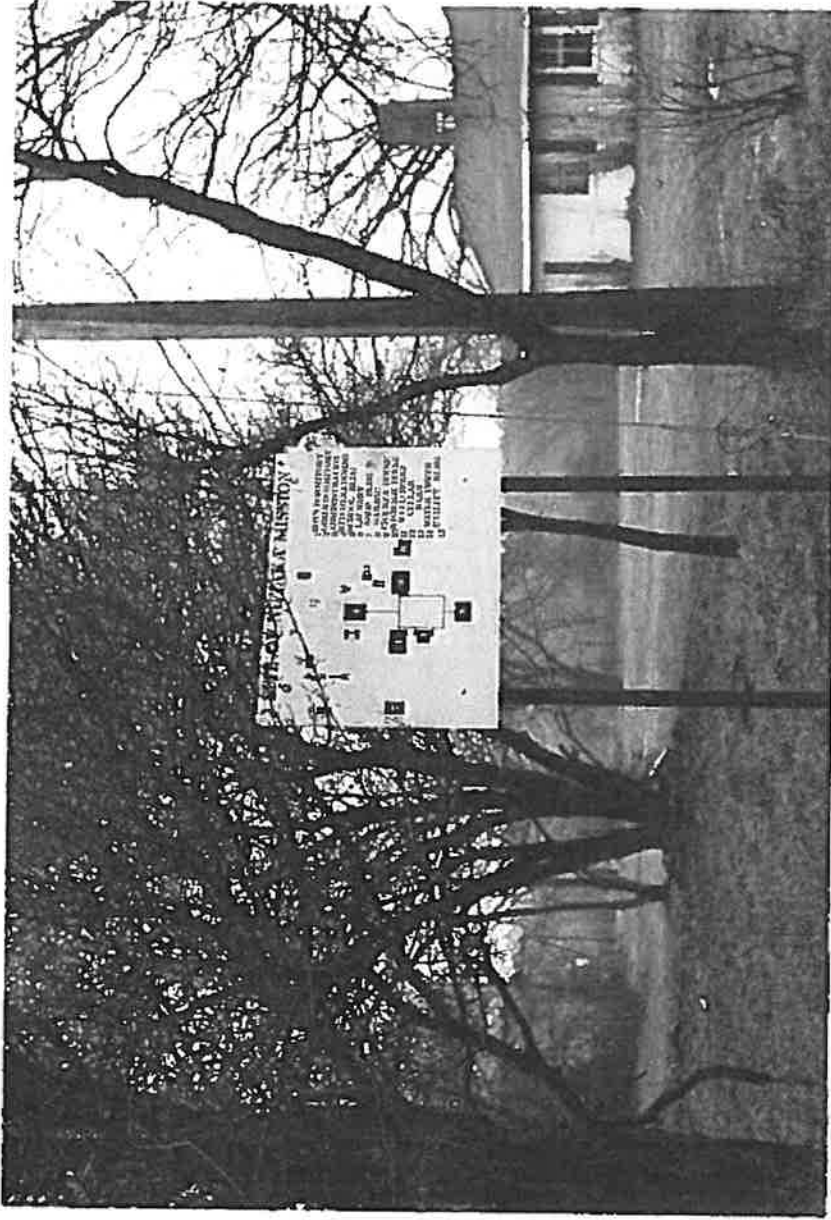
NUYAKA MISSION - OKMULGEE COUNTY
DIRECTIONAL SIGN LOCATED BETWEEN
(6) LAUNDRY AND (1) ADMINISTRAT'N.

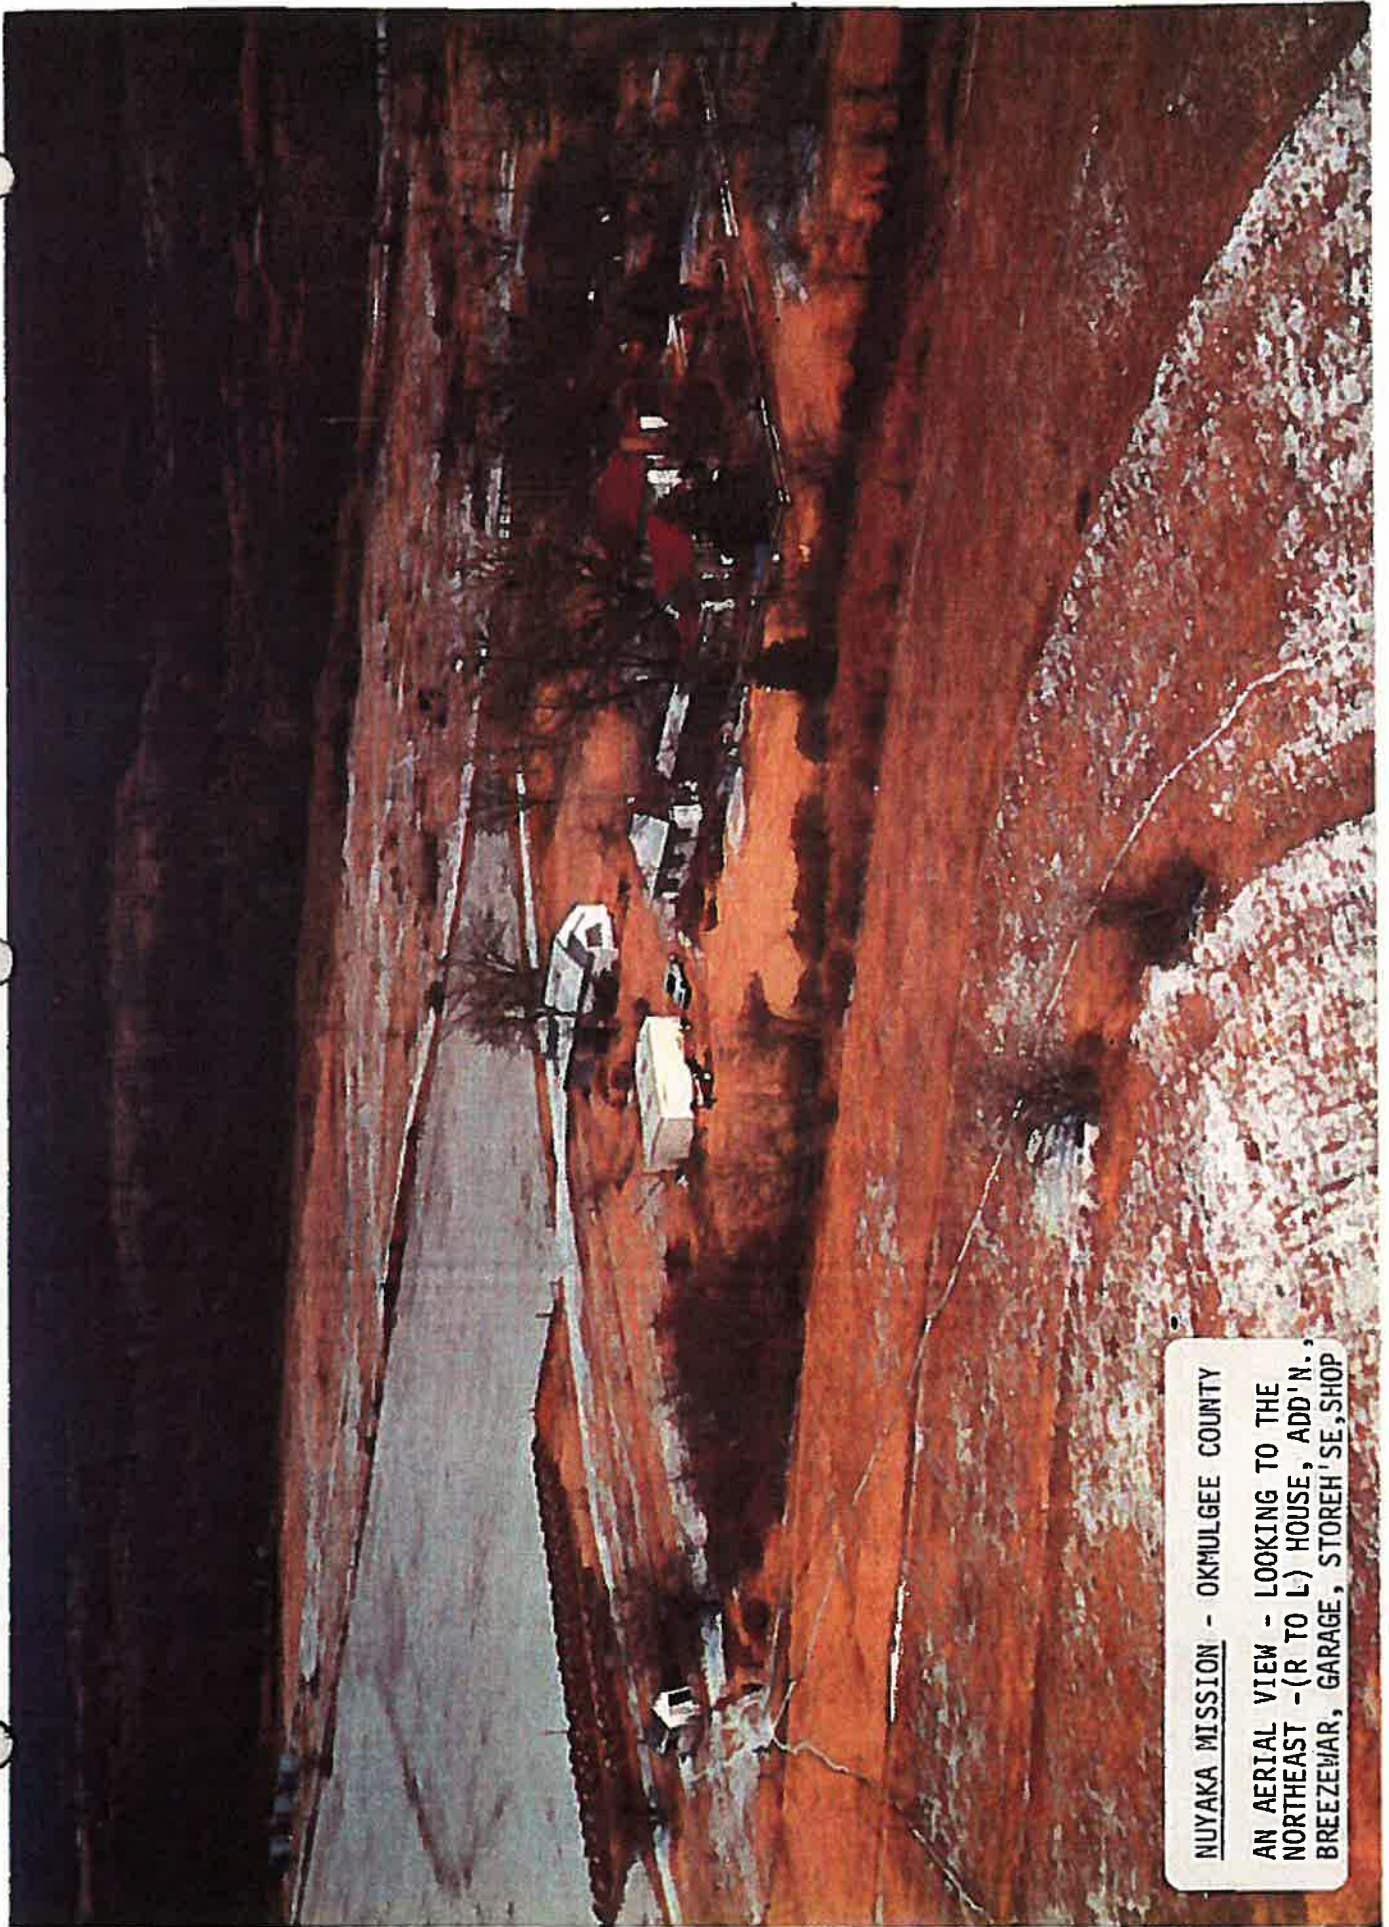
NUYAKA MISSION - OKMULGEE COUNTY
AN AERIAL VIEW - LOOKING TO THE
NORTHEAST -(R TO L) HOUSE, ADD'N.,
BREEZEWAR, GARAGE, STOREH' SE, SHOP

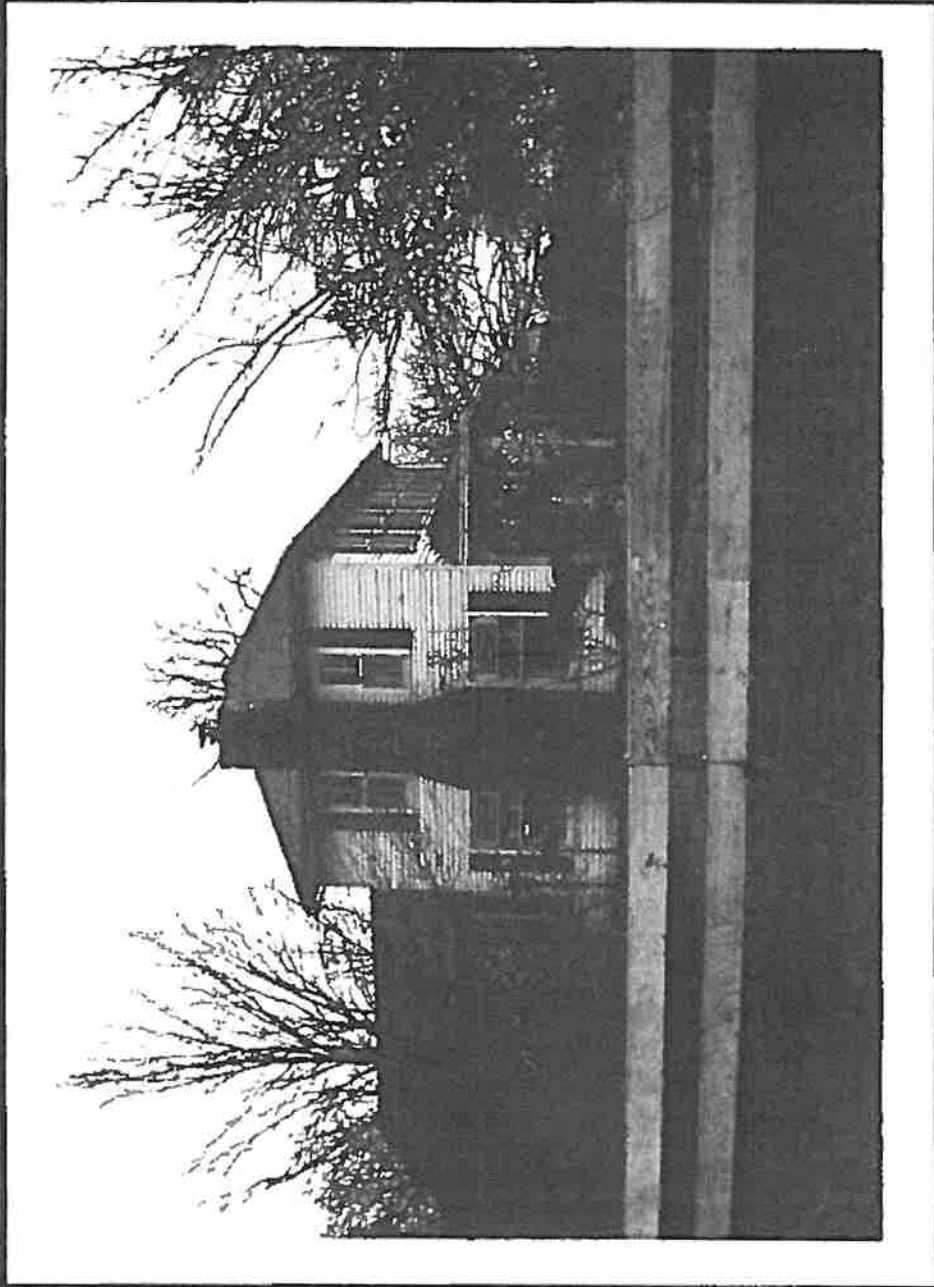
The Superintendent's house is a two story wood frame, wood clapboard sided building. The roof is less than three years old and is of barn red composition. A stone fireplace and chimney dominates the south elevation. Historic windows are 2/2, wood frame, double hung, with green painted wood shutters at all wall openings. The entry door is wood with oval glass. Living room windows at the fireplace are much larger with the upper portion of the top sash containing stained glass. A one story frame addition is attached to the west side of the house and it is to the west end of this addition that the covered walk is attached. The walk extends

VIEW OF SOUTH ELEVATION OF THE
SUPERINTENDENT'S HOUSE

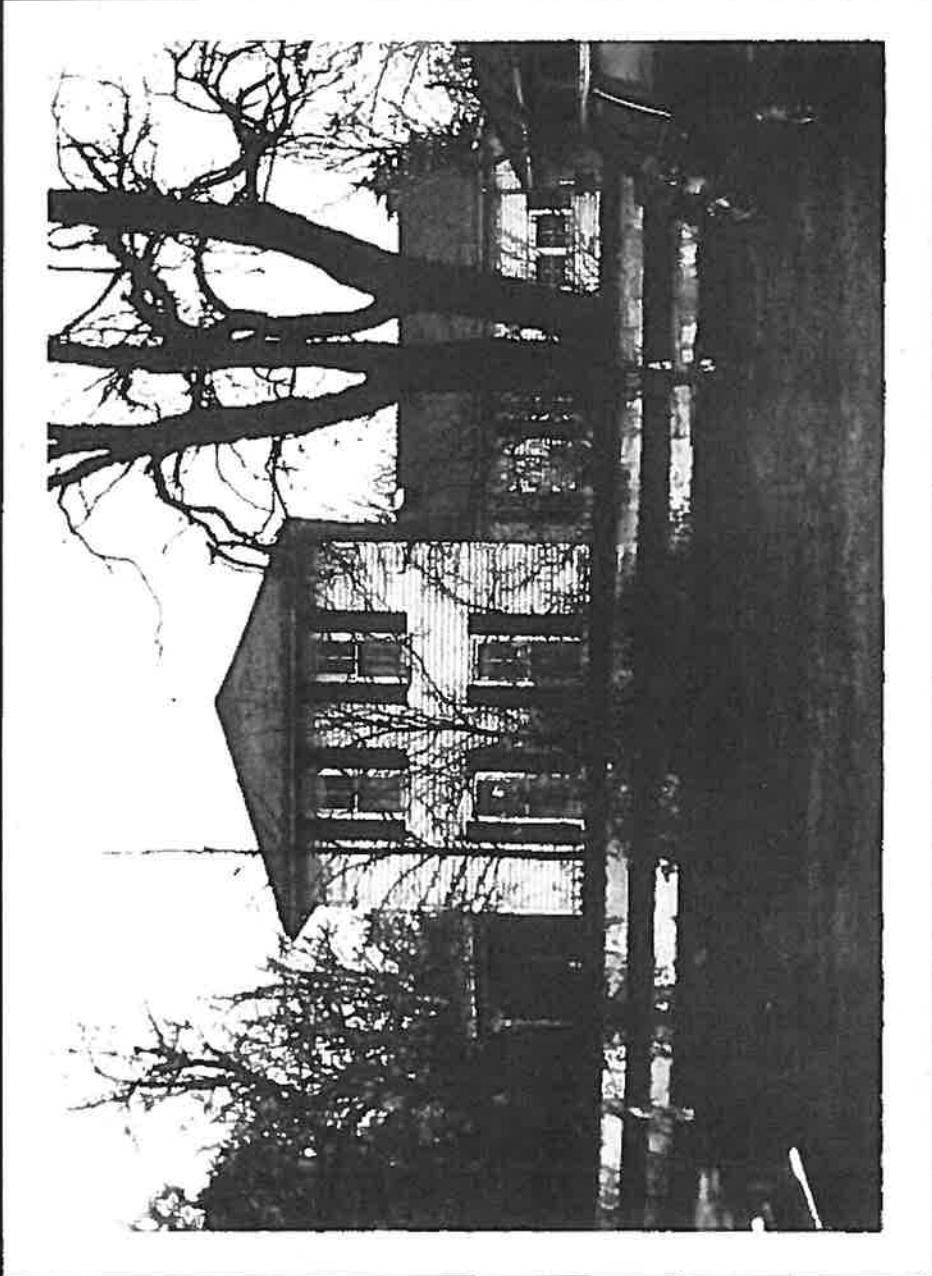
NUYAKA MISSION - OKMULGEE COUNTY
VIEW OF THE NORTH ELEVATION OF THE
SUPERINTENDENT'S HOUSE

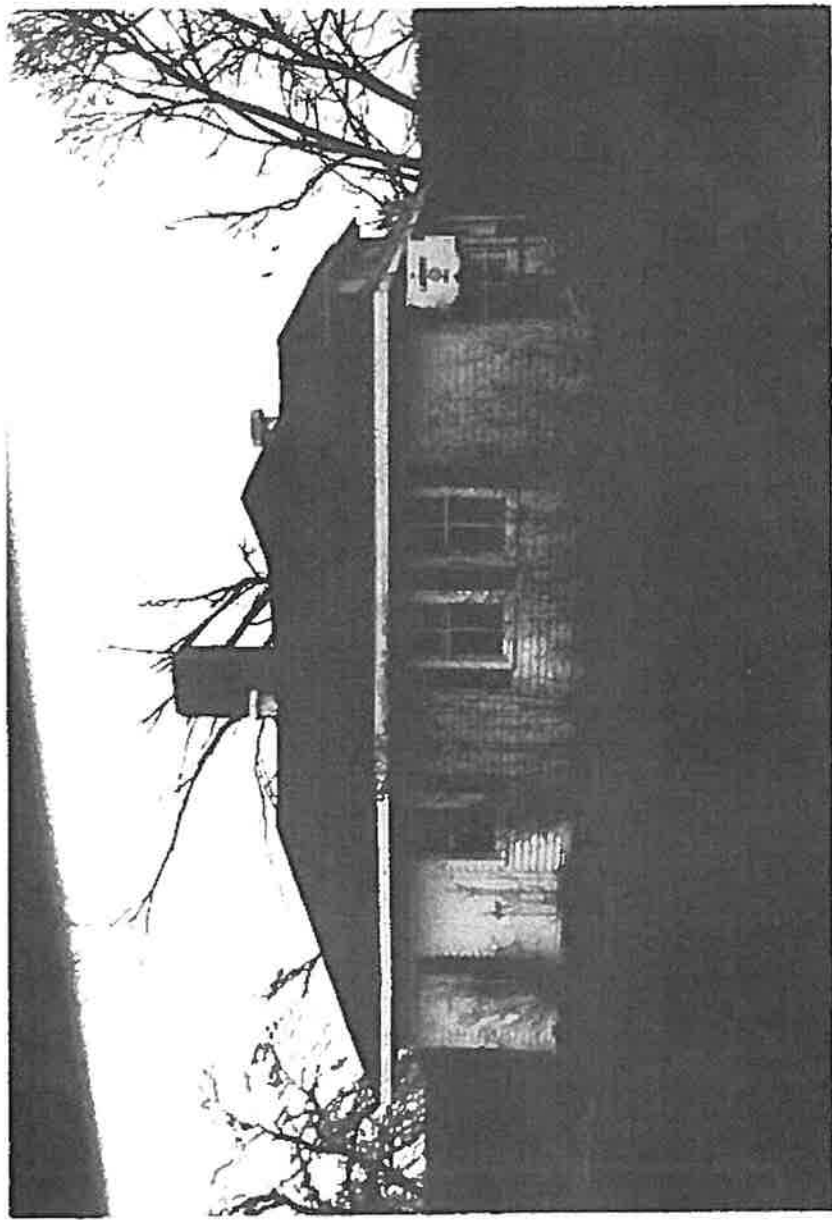
The Laundry Building is a one story wood frame, with barn red hipped roof covered with composition shingles. Windows are 2/2, double hung wood sash. No other distinguishing features except a masonry chimney of brick and metal vents through the roof. Clapboard siding is painted white. The condition is very poor. It

is presumed the interior could be judged by the exterior condition which would be poor. This building is in the historic category.

The laundry building, which once housed a steam plant, showers, and toilets, has been virtually stripped of these items, leaving little to use in the interpretation of this structure. It should also be noted that the structure has in the past been used to store hay and raise chickens and is in need of extensive repairs. It is also questionable as to what value this structure would have in the overall interpretation of the site even if restored.

NUYAKA MISSION - OKMULGEE COUNTY
VIEW OF THE WEST ELEVATION OF
THE LAUNDRY BUILDING

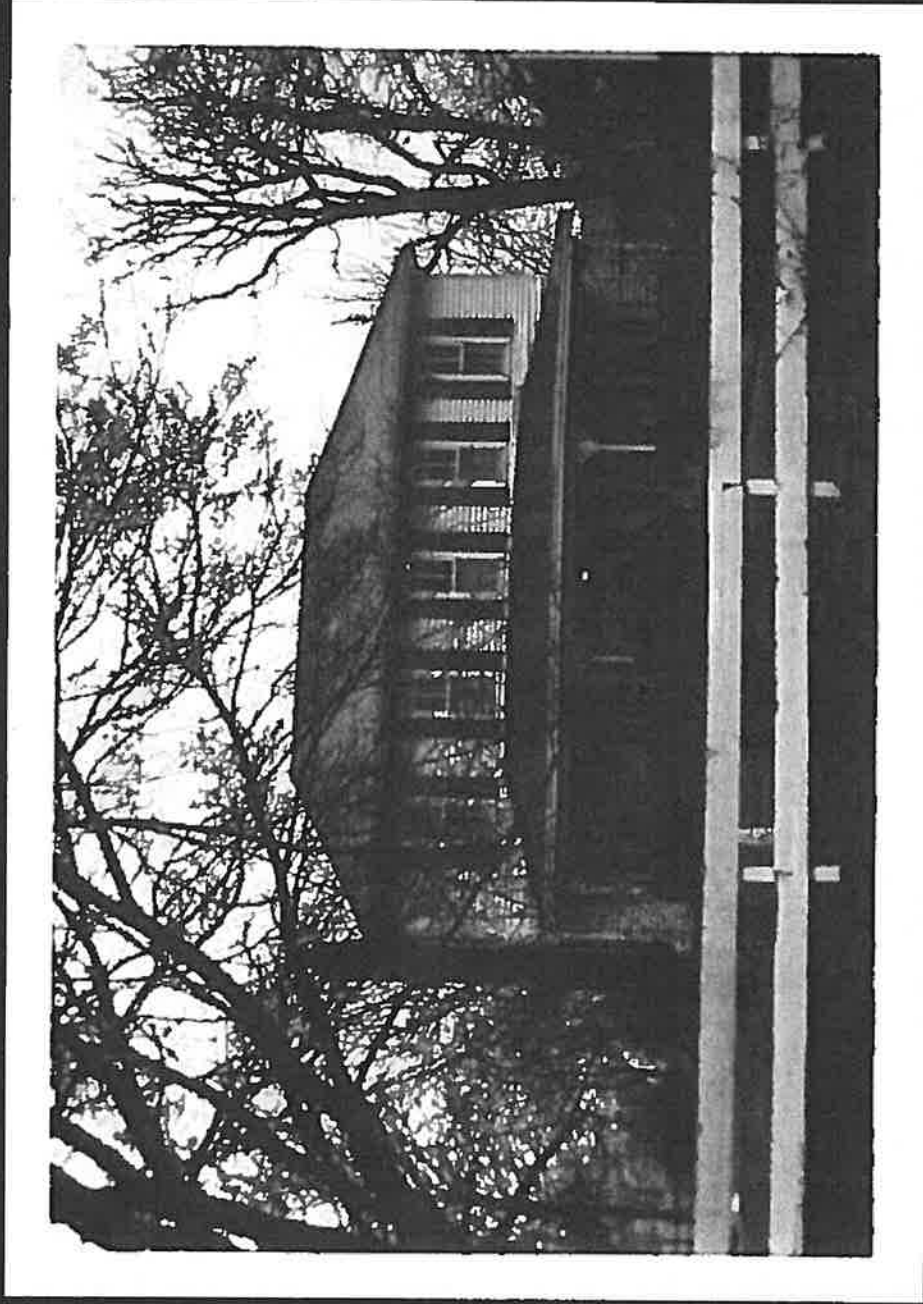
NUYAKA MISSION - OKMULGEE COUNTY
VIEW OF EAST ELEVATION OF THE
SUPERINTENDENT'S HOUSE

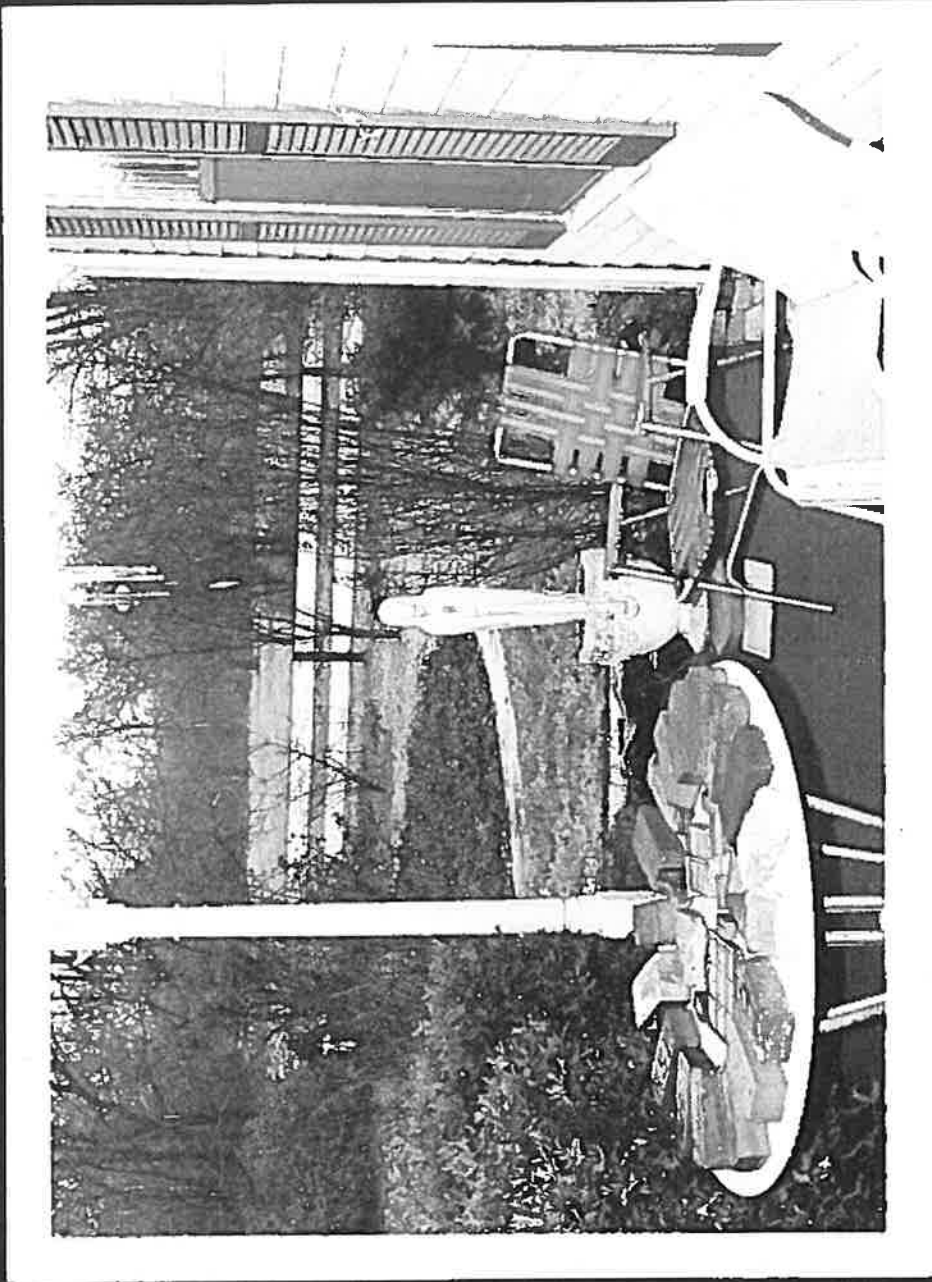
A wood board fence, 2 rails, painted white, surrounds the Superintendent's house and grounds. Evidence of semi-formal gardens

are on the south and north of the house. A good many evergreens and shrubs have places in the gardens. At the entry gate, a sidewalk goes to the porch and front door on the east.

THE FRONT PORCH AND ADJOINING
GARDEN WITH BOARD FENCE AND
NATURAL LANDSCAPE
